**FEDERAL AVIATION ADMINISTRATION  
AIRWORTHINESS DIRECTIVES  
LARGE AIRCRAFT**

**BIWEEKLY 2001-03**

## BW 2001-03

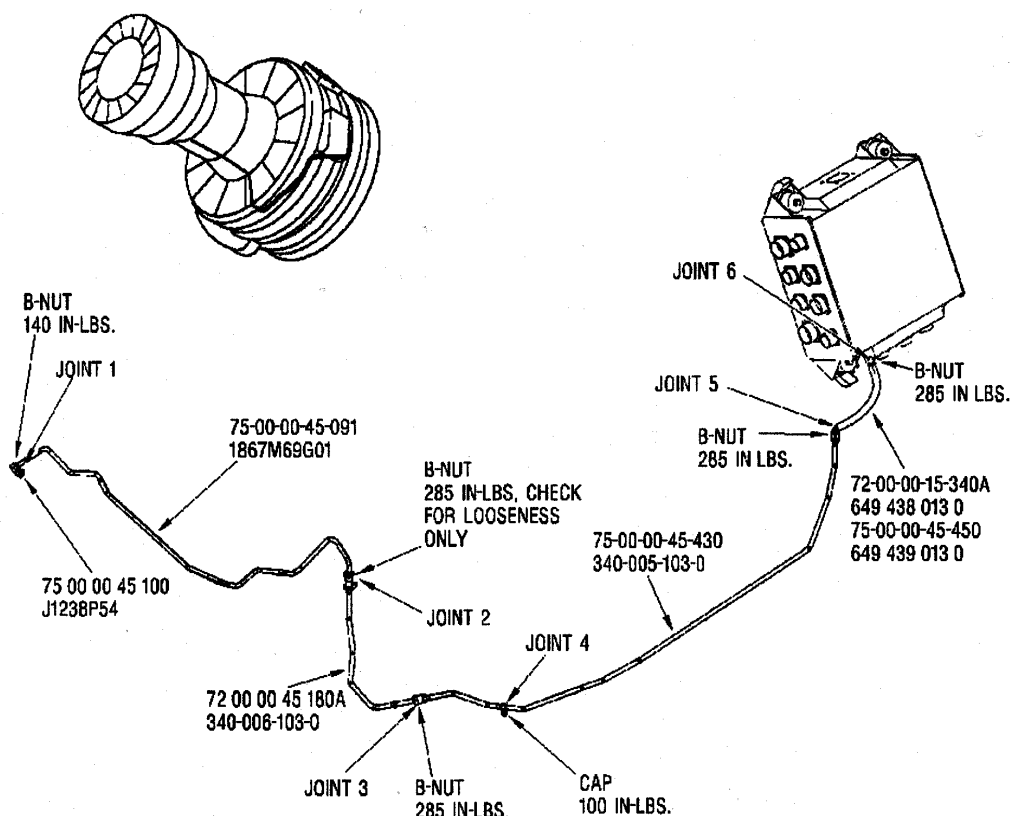
**Figure 1. Torque Values for PS3 Line Fittings**

To prevent air leakage from incorrectly torqued fittings of the PS3 pressure line, which could result in engine power loss, do the following:

- (1) Torque Joint 1 to ensure a torque value of 140 inch-pounds.
- (2) Due to accessibility limitations, check Joint 2 for finger looseness, and only if loose, torque to a value of 285 inch-pounds.
- (3) Torque Joint 3, Joint 5, and Joint 6 to ensure a torque value of 285 inch-pounds.
- (4) Torque Joint 4 to ensure a torque value of 100 inch-pounds.

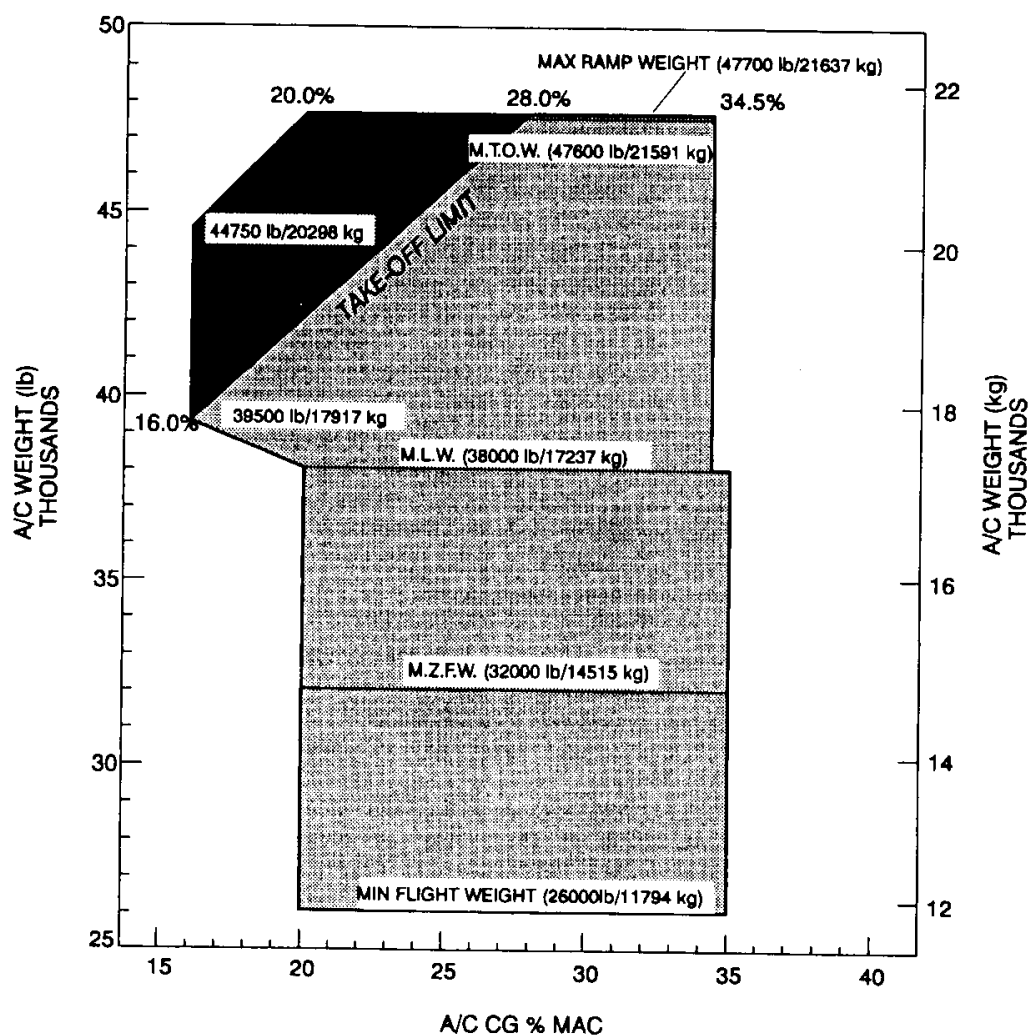
Centre of Gravity Limits (MTOW 47,600 lbs)  
Figure 02-03-1

- Due to fuel migration under conditions of acceleration and/or climb, there is a possibility that the airplane may exceed the aft Center of Gravity Limit.

Pending rectification, replace figure 02-03-1 with the attached new figure 02-03-1.

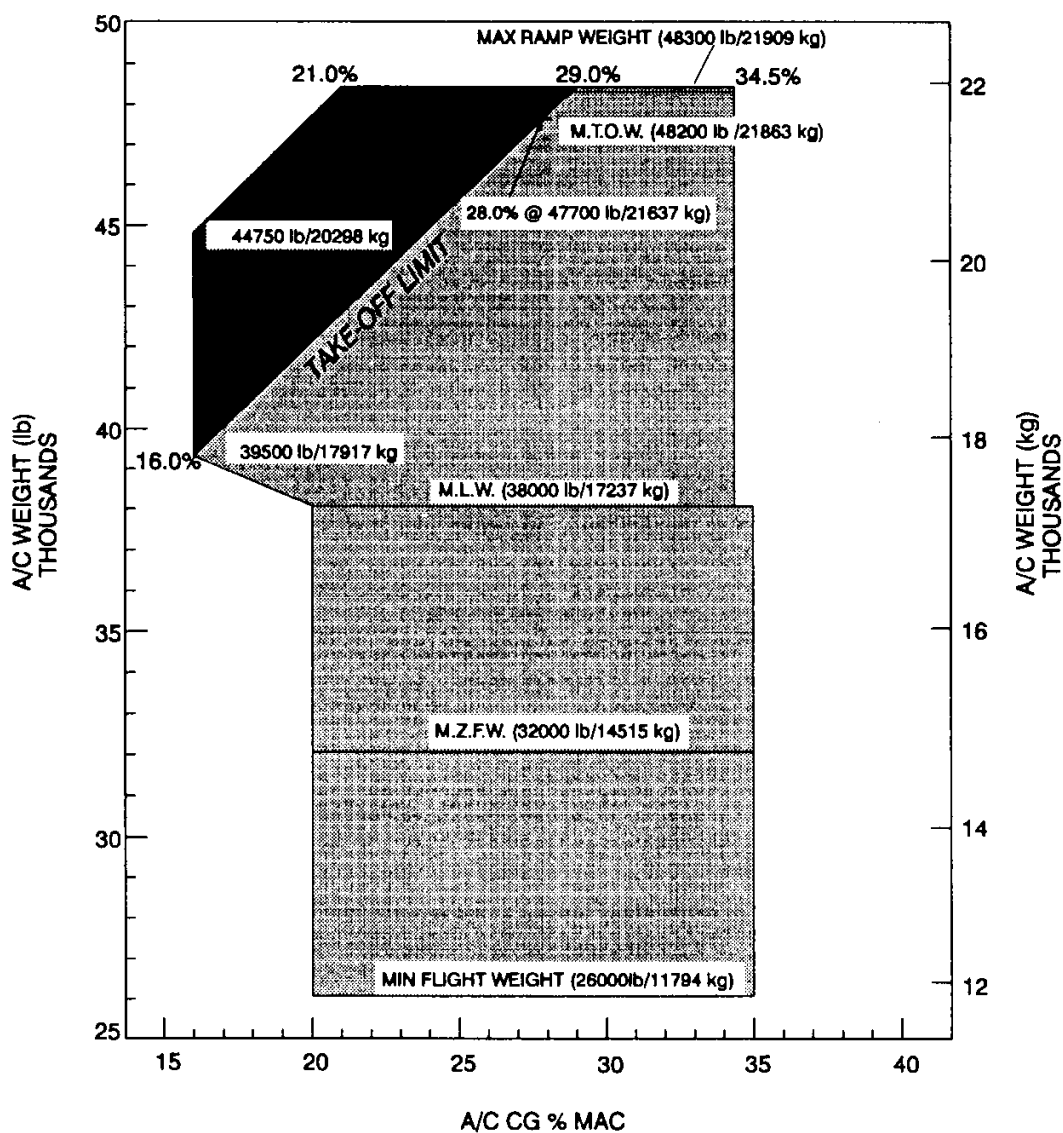
Figure 02-03-2

- Due to fuel migration under conditions of acceleration and/or climb, there is a possibility that the airplane may exceed the aft Center of Gravity Limit.

Pending rectification, replace figure 02-03-2 with the attached new figure 02-03-2.
